# KNOWLEDGE NOTE 1-3

## CLUSTER 1: Structural Measures

### Hydro-meteorological Disasters Associated with Tsunamis and Earthquakes

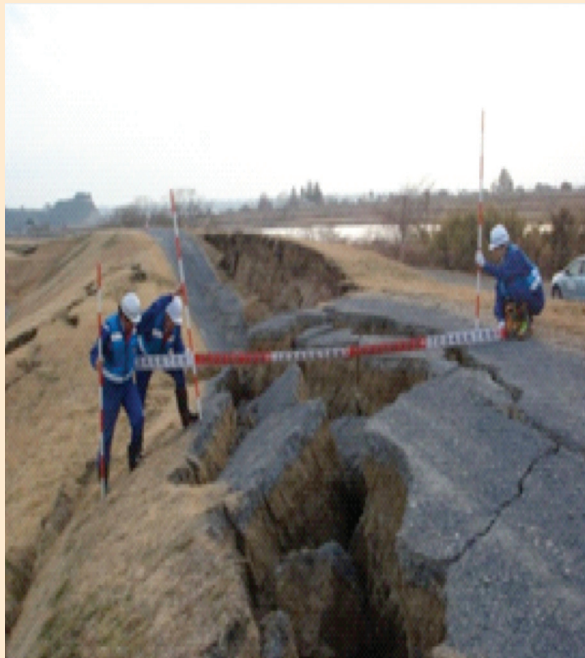
FIGURE 2: **Damage to the river dikes at Narusegawa**

The MLIT began on the day of the earthquake to assess the safety of dams and structures in some 30 rivers. Slope failure and subsidence of dikes were observed at 2,115 sites in eight rivers managed by the MLIT, mainly in the Tohoku and Kanto regions (figure 2). Local governments reported damage to a total of 1,627 sites in the rivers they manage. Many river dikes were also damaged by liquefaction caused by earthquakes. The MLIT confirmed
