# KNOWLEDGE NOTE 1-2

## CLUSTER 1: Structural Measures

# Building Performance

Prepared by Tatsuo Narafu, Japan International Cooperation Agency,
and Mikio Ishiwatari, World Bank

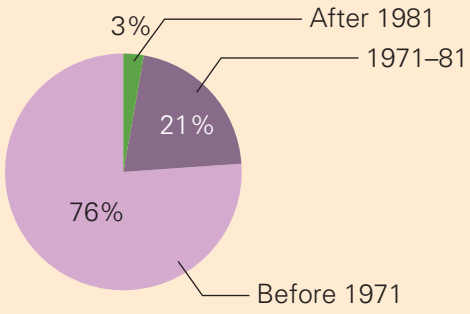
FIGURE 1: **Percentage of houses that collapsed in 1995 Kobe earthquake, by year of construction**

and economic losses estimated at more than $120 billion. Of the buildings that collapsed in the Kobe quake, 97 percent were built before 1981 (figure 1). Based on this finding, the government implemented a new law in 1995 to promote retrofitting of old buildings.
